FIRST REPORT
REGARDING
POST-DISASTER REMEDIATION
OF
2023 THESSALY FLOODING

ID#: 20249B01

October 2023

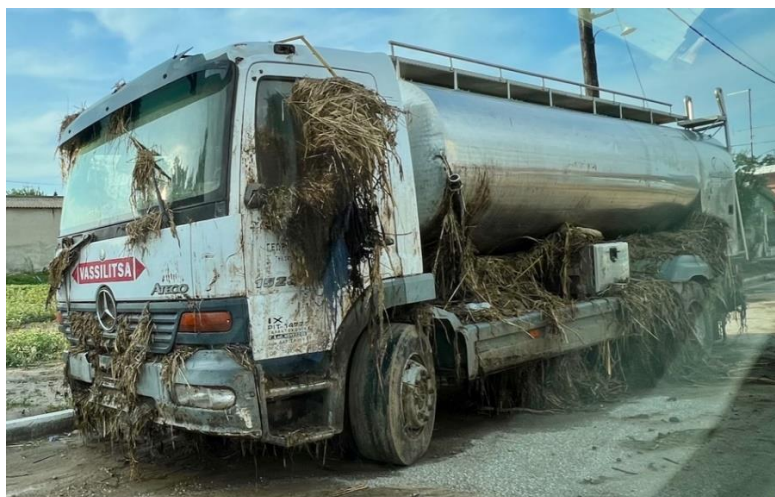
Figure 12: The flash flooding is clearly evidenced by this destroyed bulk milk transport truck in Nea Lefki which could have been driven to safety but even that was not possible.

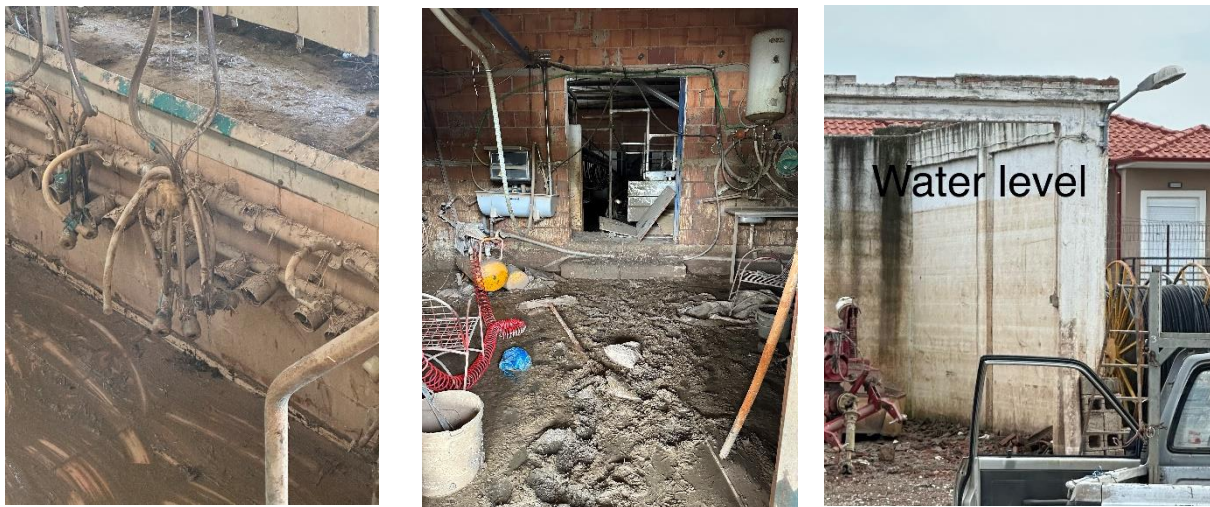
The animals that were rescued cannot be utilized any more. Seeing as most milking equipment was destroyed and the animals far too many for the farmers to milk by hand, this resulted in udder engorgement.

Figure 13: Total loss of milking machinery

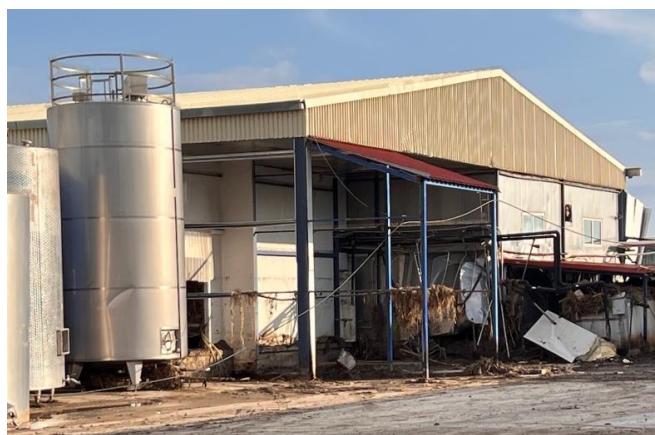
Recuperating from the damage will be very difficult seeing as the processors are now losing their clients. One processor that had a thriving export business of Feta cheese was on the way to the Anuga Food Fair and would have to inform all its clients that they could not deliver anything to them.

Figure 15: Completely destroyed Feta cheese factory.
